# Manhole Inspection Summary

Manhole # S11MM1024MH

**Location** Address: **4545 DUPONT AVE**

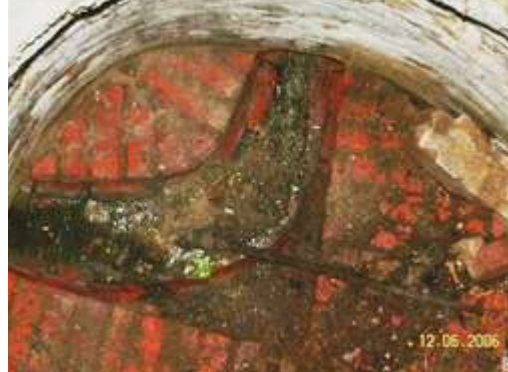
Top View

Infiltration: ☐ None ☐ Joint ☐ Cracks ☒ **Mortar** ☐ Roots ☒ **Wall**

**Bench** ☒ Exists Material: **Brick** ☐ Parged ☒ **Debris** (not Condition related)

**Surcharge** ☒ **Evidence Of Surcharge** Depth: **2** (ft.) ☐ Active Surcharge Present

Barrel infiltration. Evidence of surcharge - Bench debris. Channel debris.

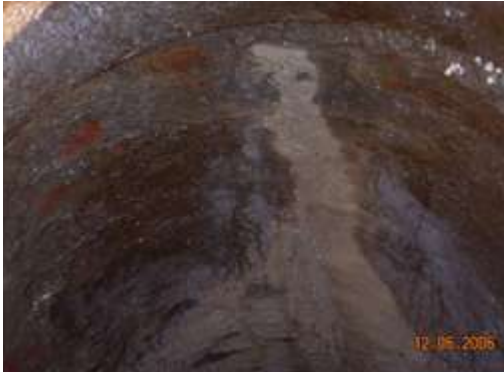
Defect

**Frame** Offset: **1** (in.) Condition: ☐ Sound ☐ Cracked ☒ **Leaks**

Condition: ☐ Sound ☐ Cracked ☐ Root Intrusion ☐ Loose Brick ☒ **Deteriorated**

Infiltration: ☐ None ☒ **Joint** ☐ Cracks ☒ **Mortar** ☐ Roots ☐ Wall

Frame leaks. Adjustment deterioration and infiltration.

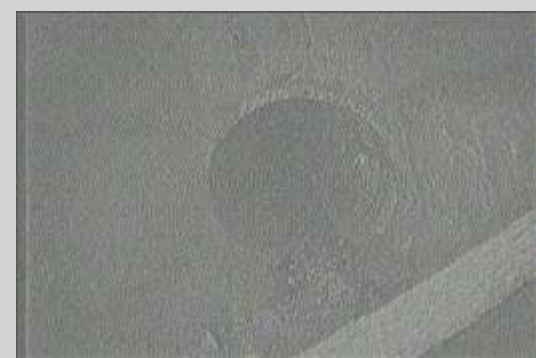
### 8 in. Circular Gravity Sewer Pipe Out @ 12 O'Clock

Deposits: ☐ None ☒ **Mud** ☐ Sludge ☒ **Debris** ☒ **Grease**

Infiltration: **Evidence** Pipe Seal Cond: **Unknown**

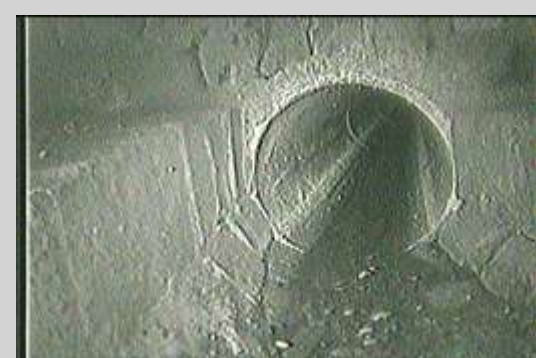
### 8 in. Circular Gravity Sewer Pipe In @ 9 O'Clock

Comments **The I9 pipe picture shows Channel deterioration.**

Condition: ☐ Sound ☐ Cracked ☐ Root Intrusion ☒ **Deteriorated** ☐ Leaks ☐ Debris

Channel deterioration.
